### SECOND MEMORANDUM REPORT

Frontispiece: Tank, 90-mm Gun, M48A2.

The United States Army Armor Board in 1957 conducted limited ballistic tests on the M48 tank (frontispiece) utilizing small arms fired at the various openings on the vehicle. The results of these tests indicated that certain areas and components of the hull and turret were susceptible to damage from small-arms fire; these were the openings around the gun shield, the vision devices, the clearance opening between the turret and hull, and the cupola.

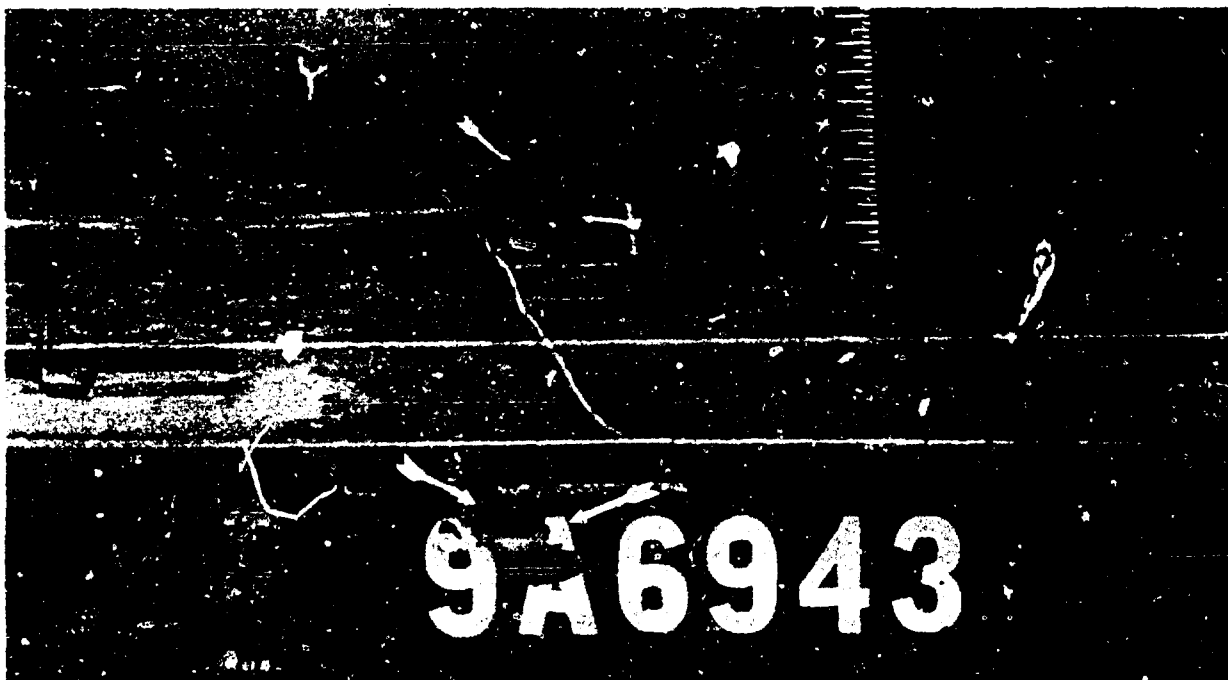
- 3.2.1.2 90° Flank Attack. One round of 20-mm, AP, M95 was fired in a direct flank attack through a fender box, impacting 1 inch below the opening between the turret and hull. This projectile scooped upward into the base of the turret, closing the 1/2-inch opening and locking the turret in the traverse operation. Fifteen minutes of labor with a cutting torch was required to free the turret (Figure 2).
- a.

Figure 2 - B29723: Turret Locked in Traverse by 20-mm, AP, M95 Projectile Penetrating Fender Box and Impacting into Turret and Hull Opening.

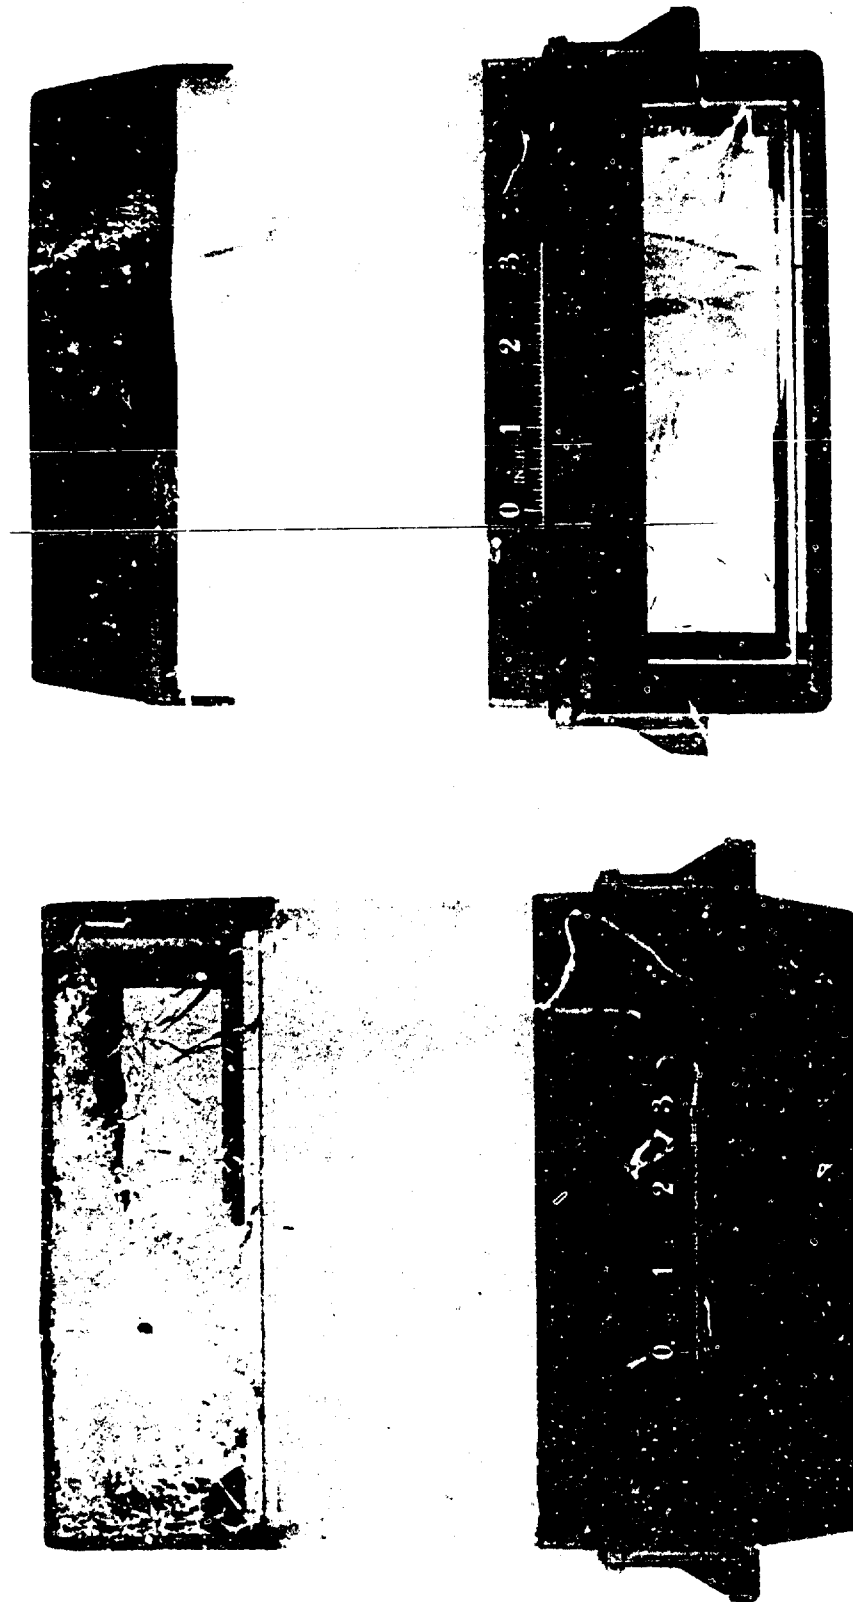
The two periscopes attacked with the caliber .30, AP, M2 projectiles suffered 50% and 85% destruction of visibility, respectively. No glass fragments were displaced from either eye prism and each periscope could have been readily replaced by the driver from within the vehicle without outside assistance (Figure 4).

Figure 4 - 59T2090 (Left) and 59T2091: Front Surface (Left) and Rear Surface Views of One M36 Driver's Periscope Impacted with One Round Caliber .30, AP, M2 Projectile.

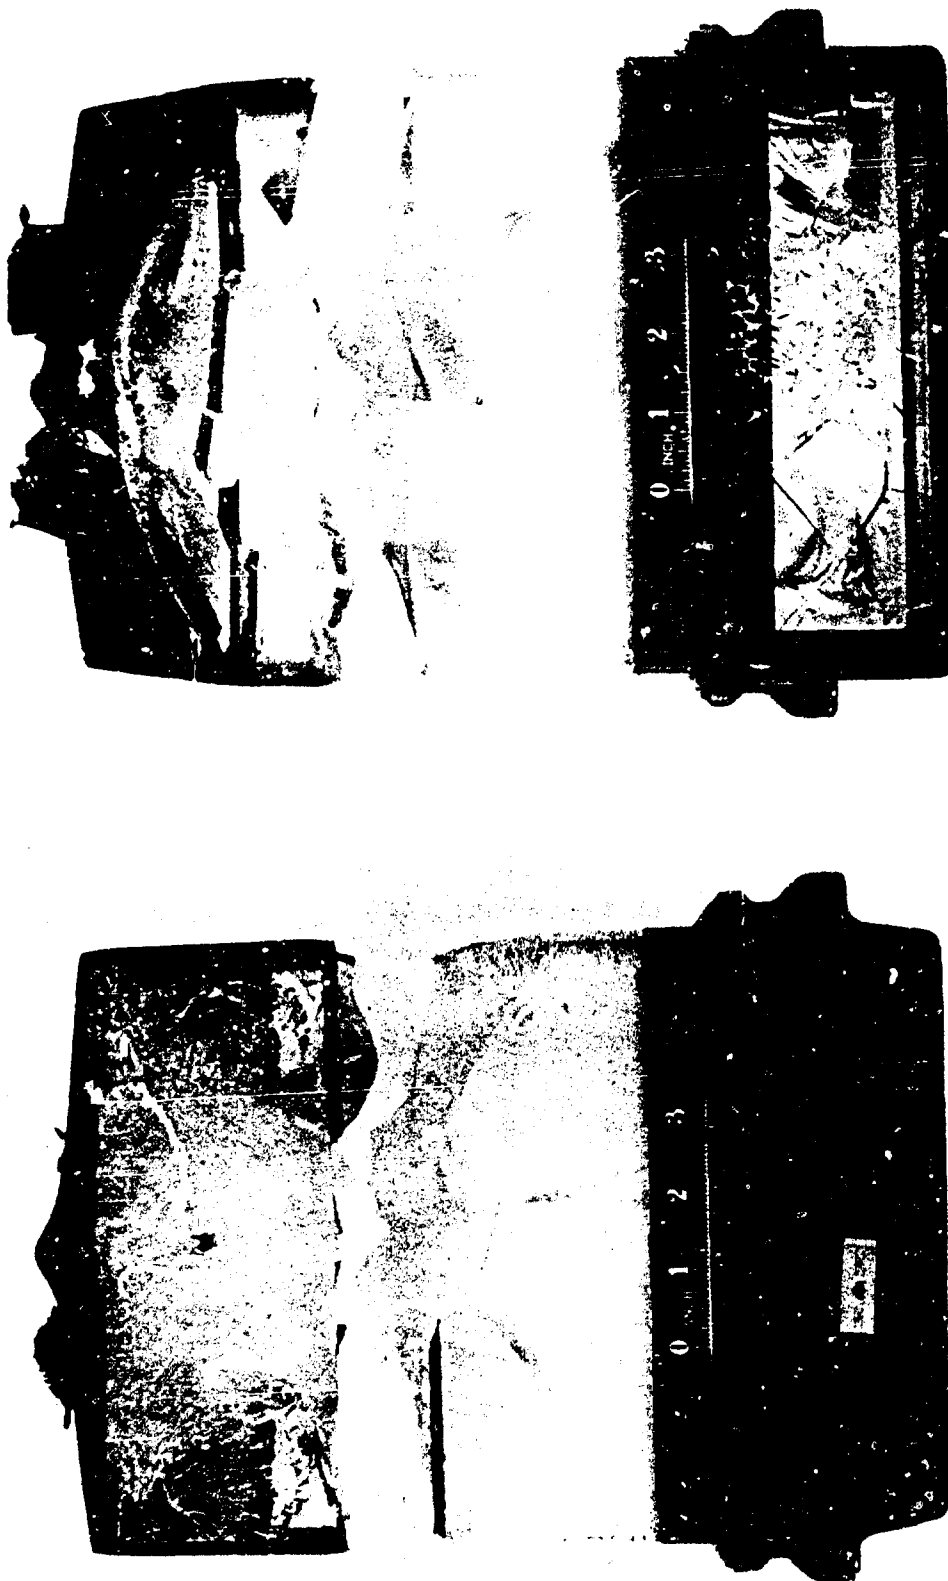
Three of the periscopes impacted with the caliber .50, AP, M2 projectiles sustained 100% destruction of visibility. In each of these three instances the plastic body of the periscope was sheared and the top prism completely displaced from its normal position (Figure 5). In all three of these cases the driver would have been able to effect a rapid, unassisted change from within the vehicle under fire. The fourth periscope in this group suffered 75% destruction of visibility and no shearing of the plastic body occurred. Although this item suffered the least damage of the four periscopes attacked with the caliber .50 projectiles it was this last unit which would have caused the tank crew the most trouble in making a replacement under fire. A 2- by 2-5/8 inch opening on the rear of the metal top prism frame petalled out over the limits of the periscope slot and would not permit the periscope to be withdrawn into the driver's compartment for replacement without assistance from someone on the exterior of the vehicle (Figure 6). The eye prisms of the four periscopes were badly cracked but no glass fragments were displaced to injure the driver's eyes, although some glass dust was observed to filter down into the driver's compartment as a result of the projectile impacts in the upper prism.

Figure 5 - 59T2092 (Left) and 59T2093: Front Surface (Left) and Rear Surface Views Showing Fracturing of Plastic Body of M36 Driver's Periscope When Attacked with a Caliber .50, AP, M2 Projectile.

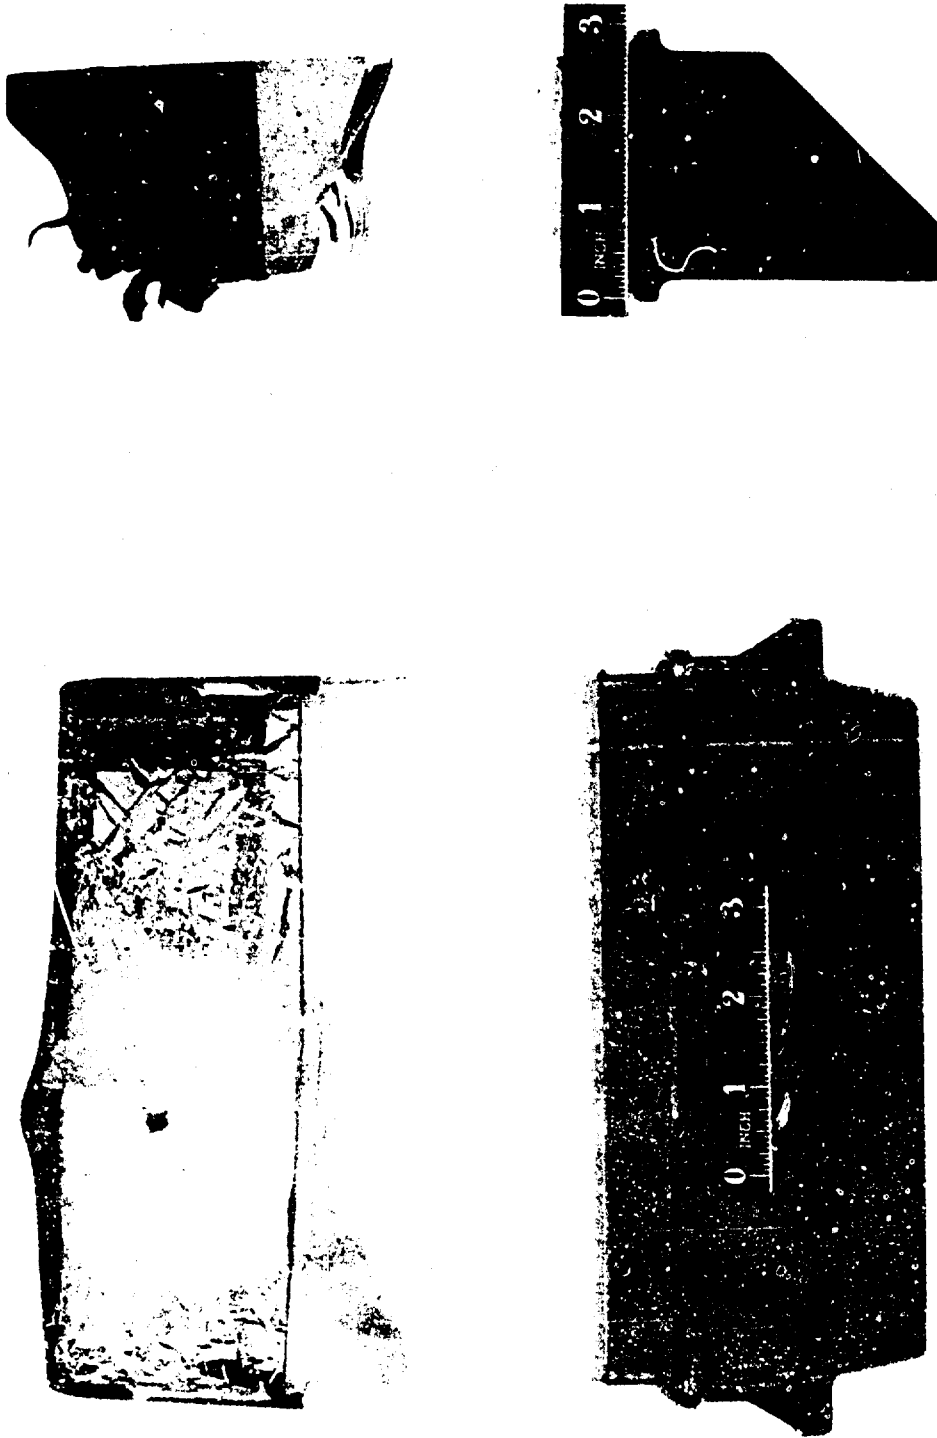
Figure 6 - 59T2096 (Left) and 59T2097: Front Surface (Left) and Side Surface Views Showing Petalling of Objective Prism Metal Case Caused by One Impact of a Caliber .50, AP, M2, Projectile.

velocity to injure the driver's eyes. The fact should be noted that in the design of future periscopes consideration might be given to discarding the metal case around the sides and rear of the outer prism. It is felt that by this action the possibility of having a damaged periscope jammed in position by petal'ing of the rear metal case would be eliminated and replacement by the driver from within the "buttoned-up" vehicle would be facilitated.

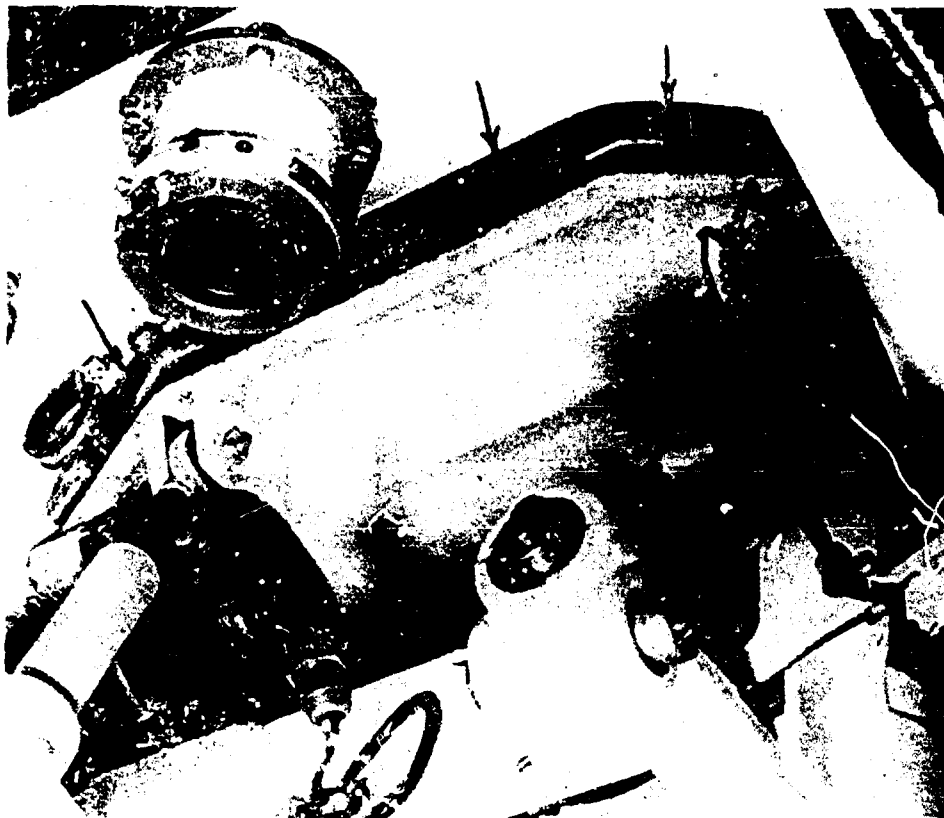
Figure 12: Black Arrows Indicate Splash Guard Installed at Top of MG Cradle and Top of Cupola.

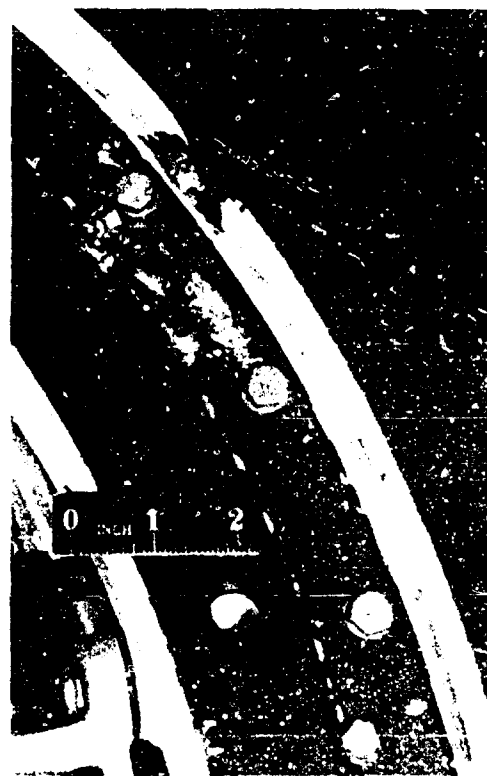
The second area to be subjected to an immobilization test was the opening between the cupola and the cupola base ring. Five rounds of caliber .30 AP ammunition were impacted into this opening before the traversing operation of the cupola was prevented. After the first two impacts a grinding noise was heard and manual traverse began to get more difficult. These conditions progressively increased with each succeeding impact until impact number 5 locked the cupola to a  $7\frac{1}{2}^{\circ}$  right traverse and  $7\frac{1}{2}^{\circ}$  left traverse (Figure 14). One other M13 cupola was subjected to the immobilization test of the traversing operation. In this case one round of caliber .50 AP ammunition was fired into the opening between the cupola and cupola base ring and completely locked the cupola so that it could not be traversed (Figure 15).

Figure 15 - B32061: Damage to Cupola Mounting Ring and Bearings Caused by One Round of Caliber .50, AP, M2 Ammunition.
